### Rotary dryer

Kronospan is the world largest manufacturer of wood panel products and laminate flooring.

On their site at Wrexham, UK they had many problems with their dryer.

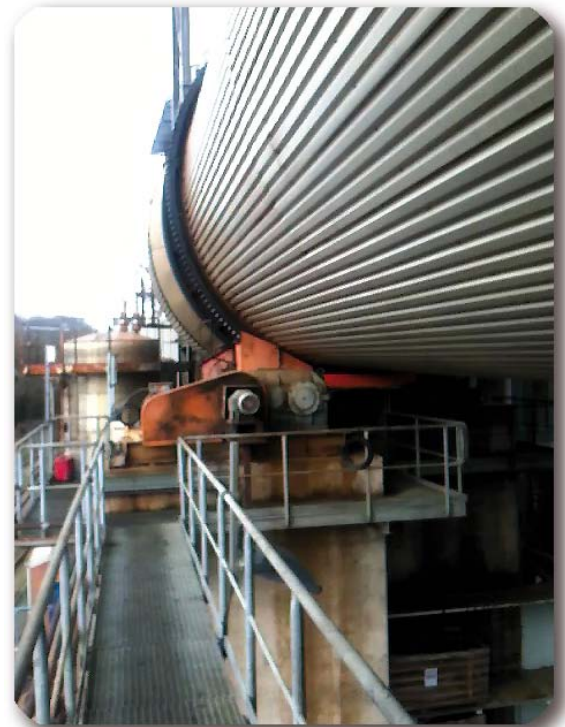
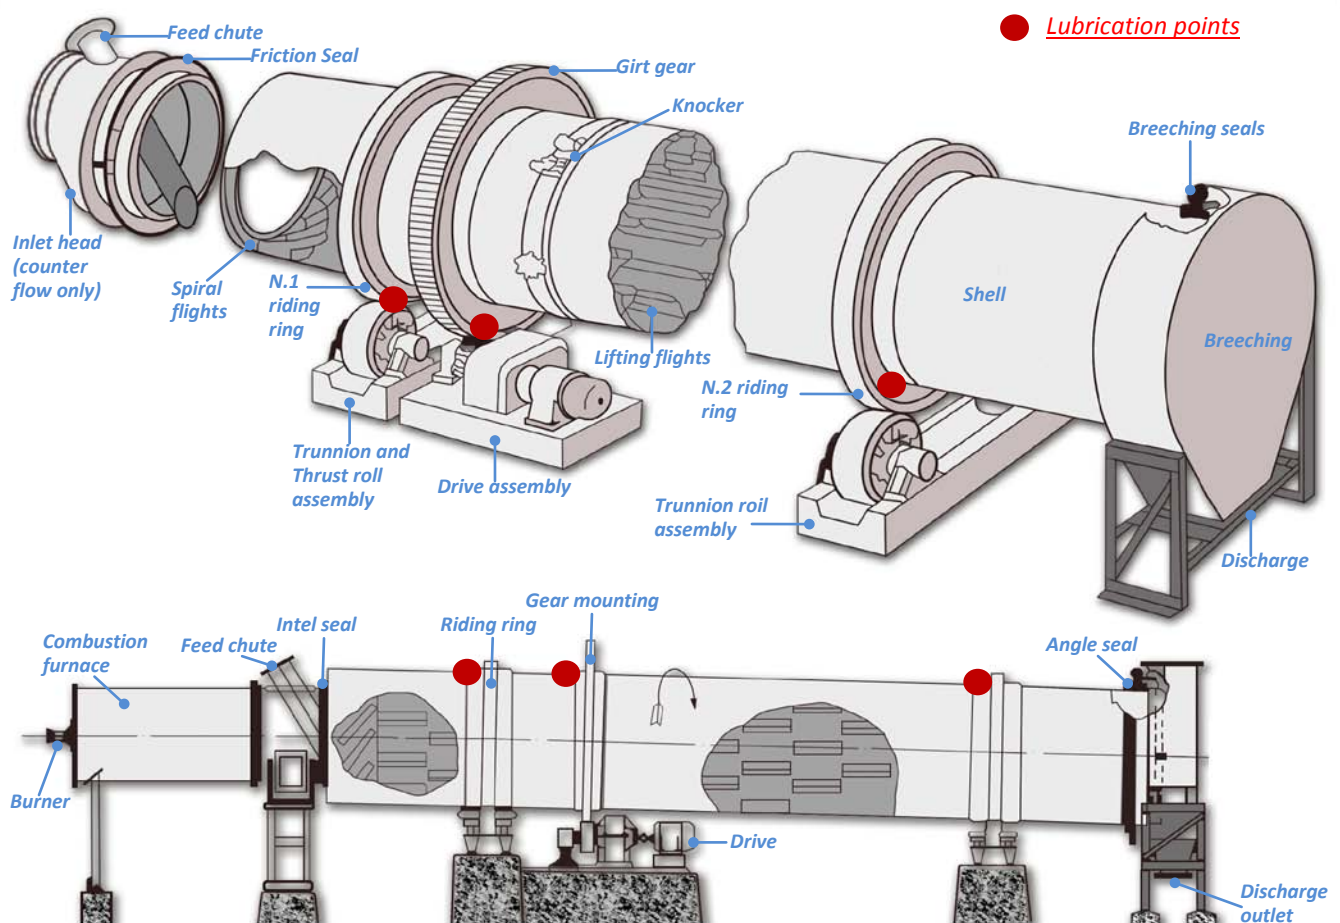
The rotary wood dryer turns on two riding rings and a girth gear. Whilst turning hot gases are blown through which reduces the moisture of the wood. These three areas need to be lubricate to ensure smooth operation and turning.

If they are not lubricated the gears deteriorate quicker which leads to inefficient running and increased energy costs due to increased load on the motors

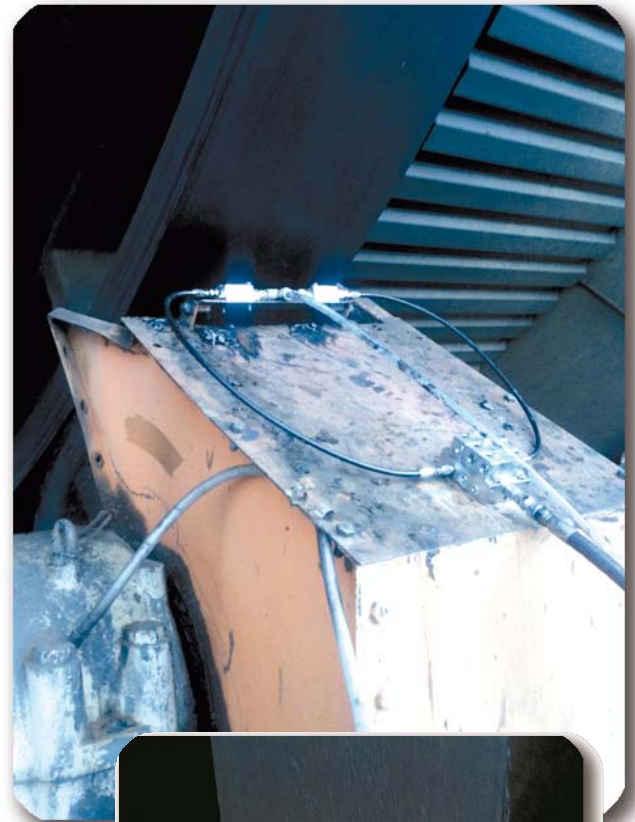
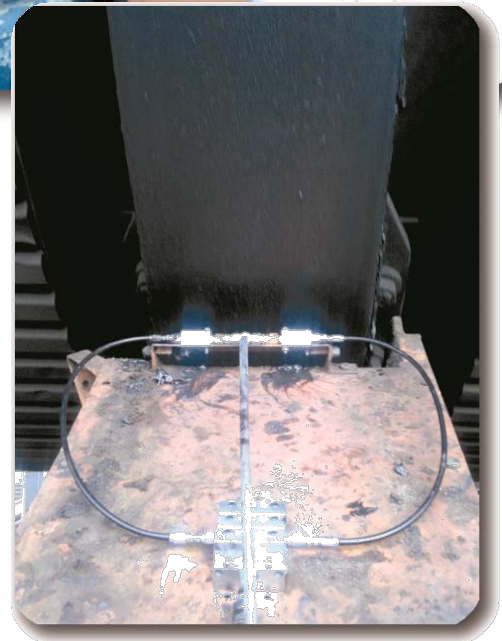
- **Pneumatic 234700 pump**
- **One master progressive block to feed the pump**
- **3 secondary progressives blocks.**

The grease needs to be sprayed on using DropsA 1132100 spray valve which has 400 mm coverage. DropsA also included an air delay timer which is a feature on the VIP5 Plus controller. This allowed the air to remain on to flush out the grease for up to 1 minute after the pump had stopped operating. If this is not done then grease builds up in the line and sawdust can block the nozzle tips.
